Yarra Bicycle Users Group

Cyclist Conflict Issues at Pigdon / Canning Street Roundabout – April/May 2006

Submission by Steve Barnett and Chris Star

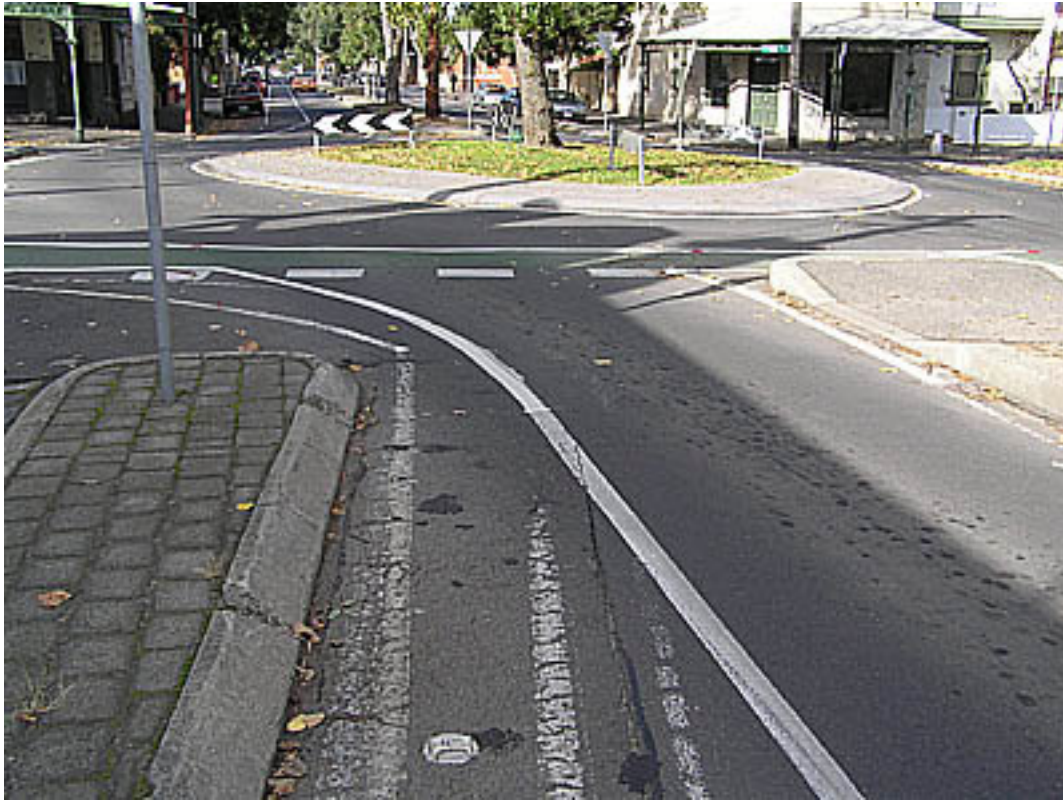
5. Pigdon Street looking east.

The raised entry choke & median would remain. The crossing would be raised to the same level across the entry to the roundabout.

Line marking stripes could be painted on the face of the raised crossing as an indicator to motorists.

Note that drainage runs under the footpath westbound from Canning St to Pigdon St. This raised crossing should not cause water to pool in the roundabout.

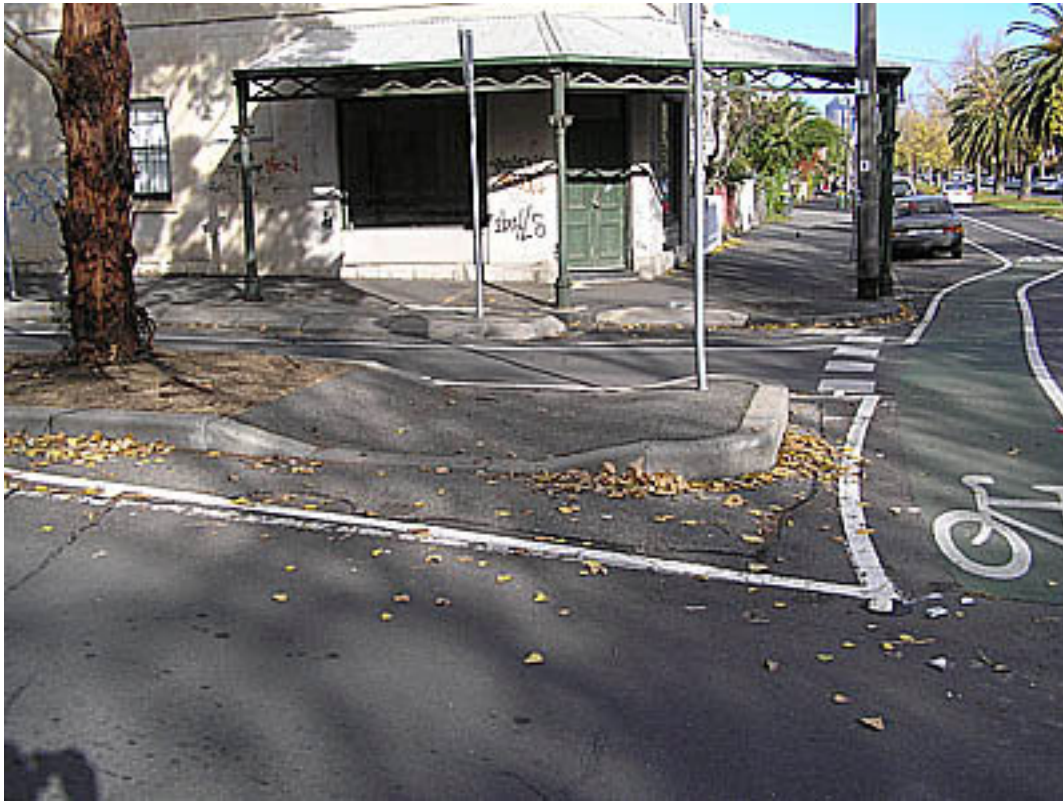
Pigdon Street looking south.

A raised crossing with line marking would have the effect of moving the 'Give Way' broken line away from the roundabout.

In this case a raised crossing would need a drainage conduit under it.

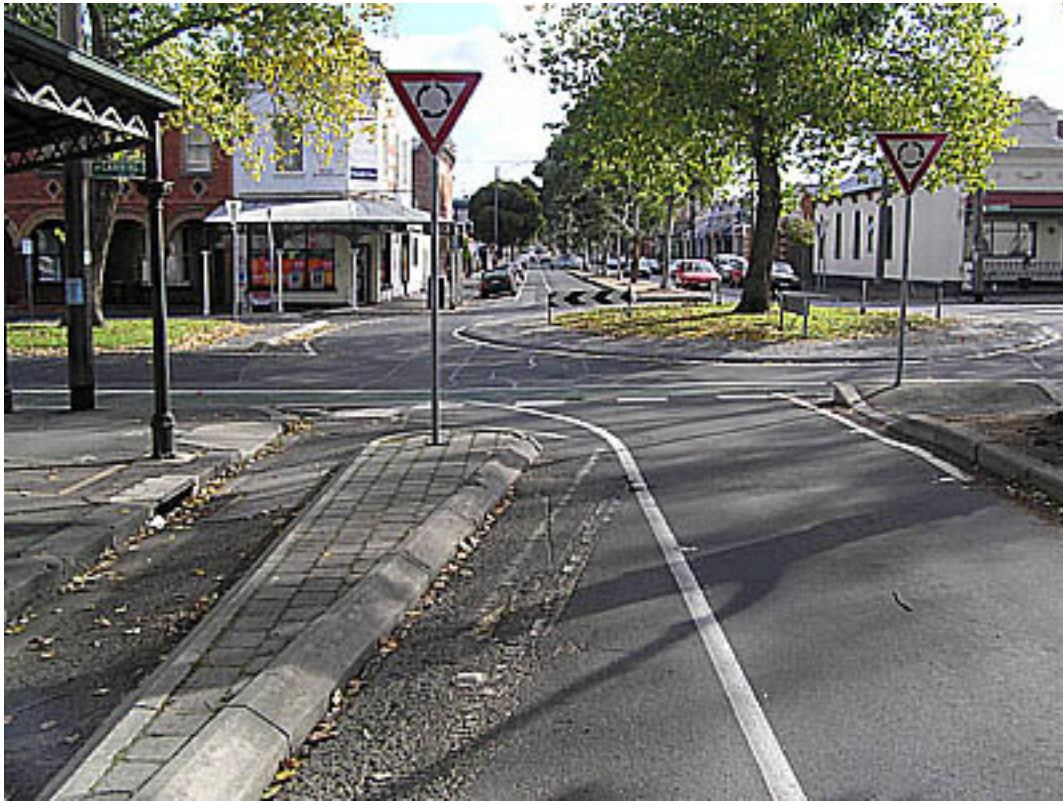
Pigdon Street looking west.

A raised crossing would ramp up from near the right hand lane marking in this photo.

A new streetlight on the Pigdon Street median strip would improve road user visibility

The drain can be seen at left.

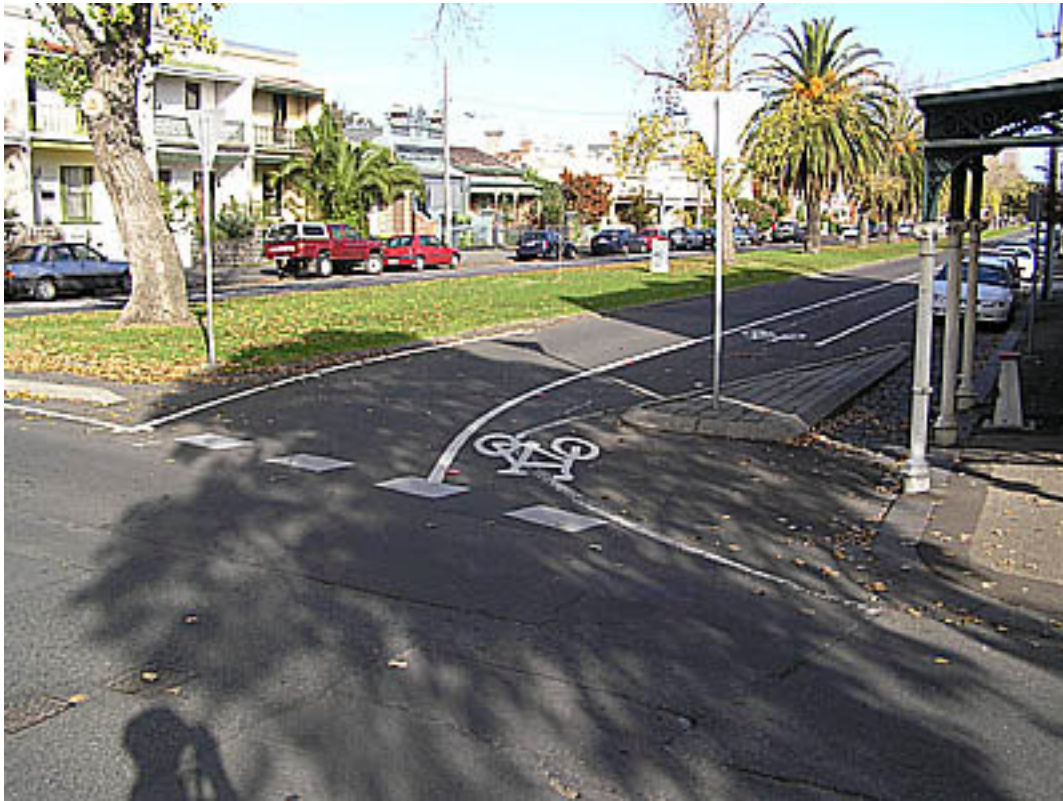
Pigdon Street looking south

A raised crossing would ramp up from the existing pram ramp in front of the Milk Bar.

This is the first intersection that cyclists encounter after riding up from Johnston Street and many maybe unprepared for a busy roundabout.

A raised ramp would make cyclists decrease speed and also make them more aware of the changed traffic conditions.

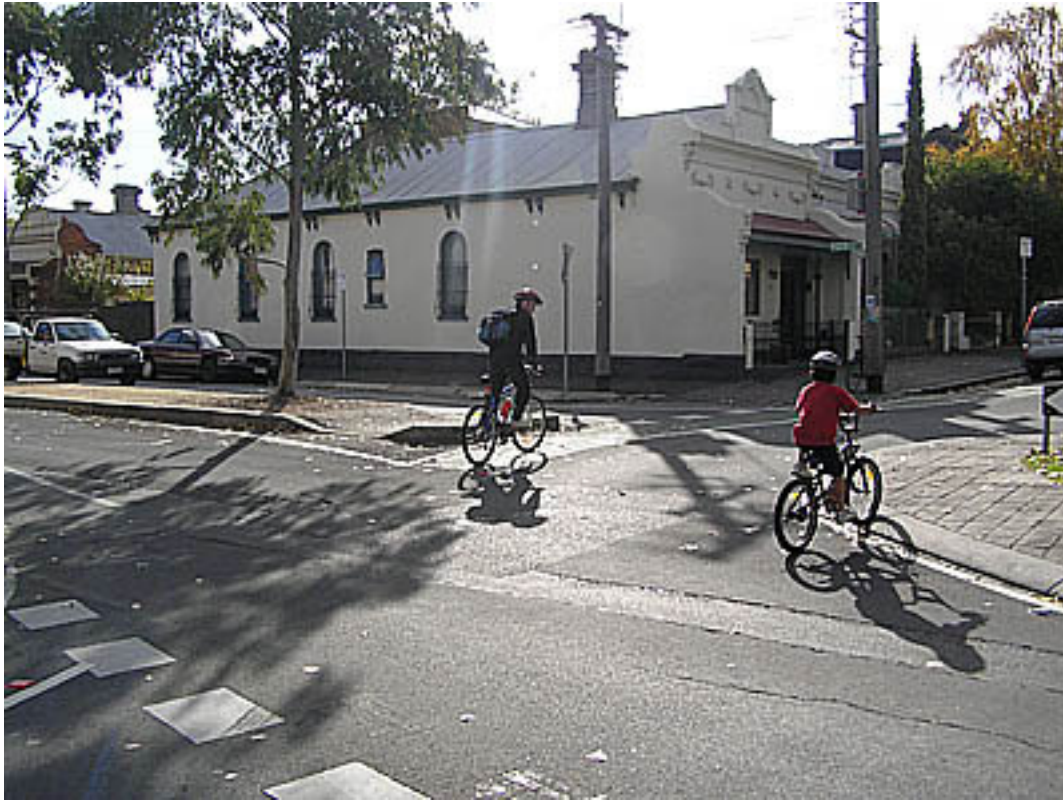
Pigdon Street looking north.

Again, a raised pavement treatment here would make motorists decrease speed before entering the roundabout.

Placing a new street light near the existing tree on the median strip would also greatly enhance road user visibility.
